**STORMWATER MASTER PLAN  
FOR  
WILLISTOWN TOWNSHIP, CHESTER COUNTY,  
PENNSYLVANIA**

Submitted: April 30, 2024

Herbert, Rowland & Grubic, Inc.  
501 Allendale Road, Suite 203  
King of Prussia, PA 19406  
484.460.7050  
[www.hrg-inc.com](http://www.hrg-inc.com)

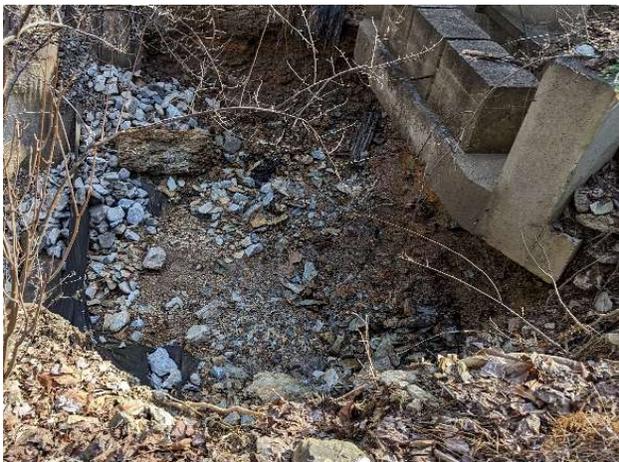
Figure 2: Undercutting of outfall

A few outfall locations were noted to have drainage issues both upstream and downstream of said outfall. GPS collection of these drainage issues were outside the scope of this study. However, when visible, major deficiencies were noted in the database for future analysis and data collection. Notably, the outfall from a private basin into the tributary for the Little Valley Creek along North Cedar Hollow Road showed significant erosion issues. The outfall has experienced severe erosion underneath it and remediation should be considered in future stormwater infrastructure replacement/rehabilitation projects. Figure 2 documents evidence of the outfall's condition.

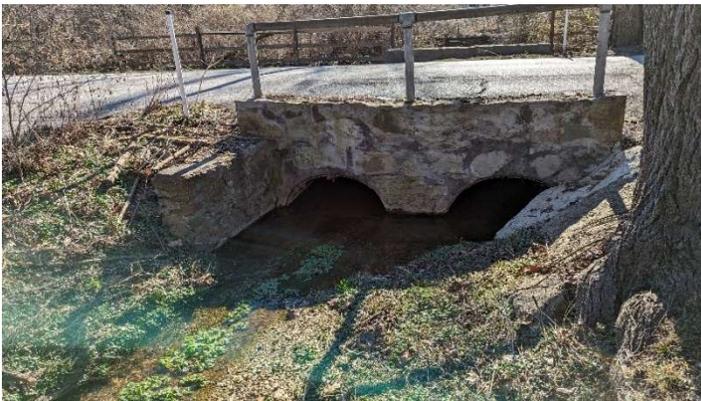
Cause of Problem:	<ul style="list-style-type: none"> <li>■ Failing and undersized culvert pipe; pipe capacity issues</li> <li>■ Debris build-up at culvert; flow-blockage</li> <li>■ Sediment build-up within culvert; flow-blockage</li> <li>■ Lack of upstream stormwater management features; minimal stormwater controls</li> </ul>

Figure 5: View of upstream face of culvert

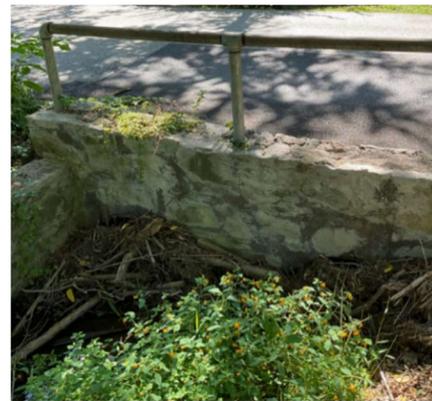
Figure 6: Debris build-up noted during inspection

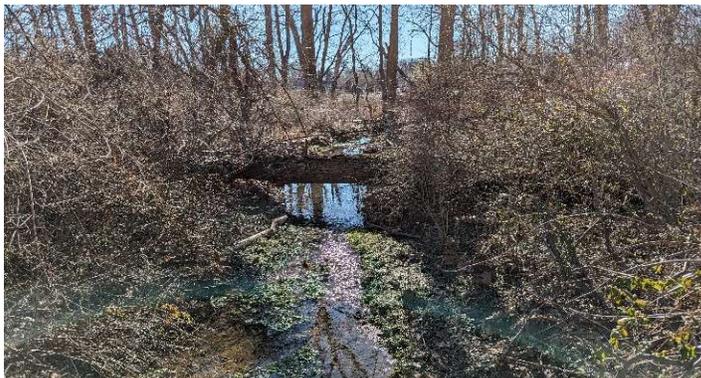
Figure 7: View of Crum Creek, downstream of culvert

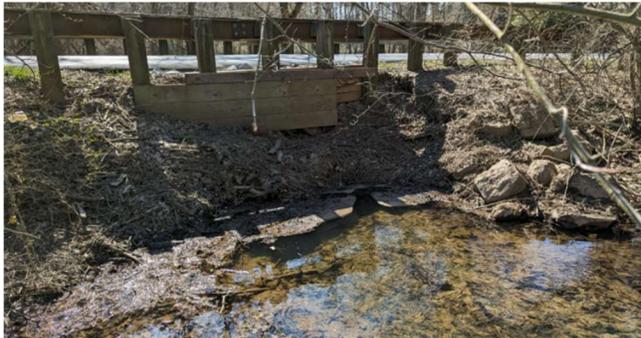
Figure 9: Upstream view of culvert with debris

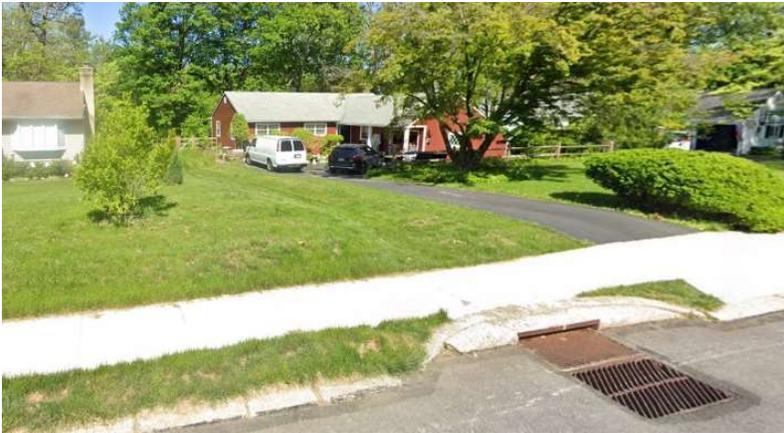
Cause of Problem:	<ul style="list-style-type: none"> <li>■ Lack of adequate inlet collection system</li> <li>■ Pipe capacity issues (i.e. undersized, concrete swales increase flow rates and runoff volume). Note: storm sewer pipe network downstream of Problem Area was not locatable during field data collection due to dense vegetation.</li> <li>■ Lack of upstream and downstream stormwater management features; minimal stormwater controls</li> </ul>

Figure 13: Inlet and swale at location of flooding on Chetwynd Road

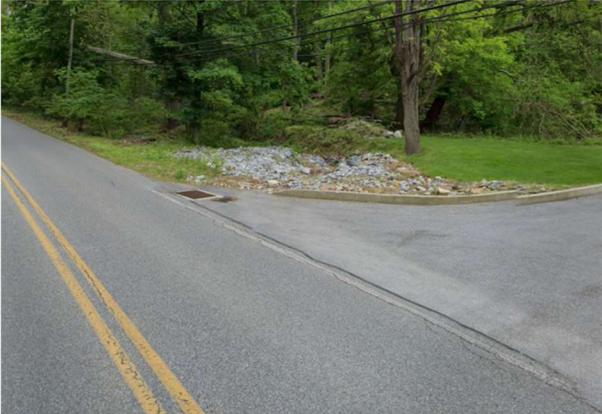
<p><i>Figure 16: Connection from Tributary of Little Valley that overflows directly to North Cedar Hollow Road</i></p>	<p><i>Figure 17: Severely eroded channel leading from private outfall to Little Valley Tributary</i></p>

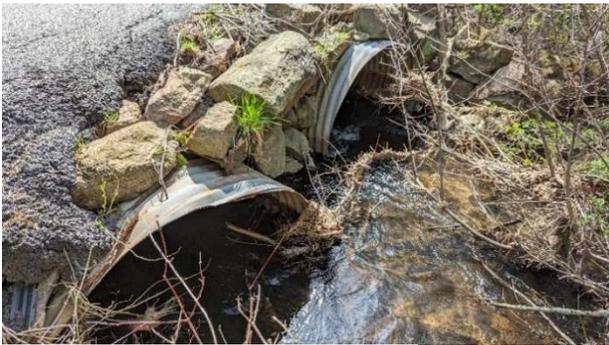
Figure 21: Upstream view of dual culvert

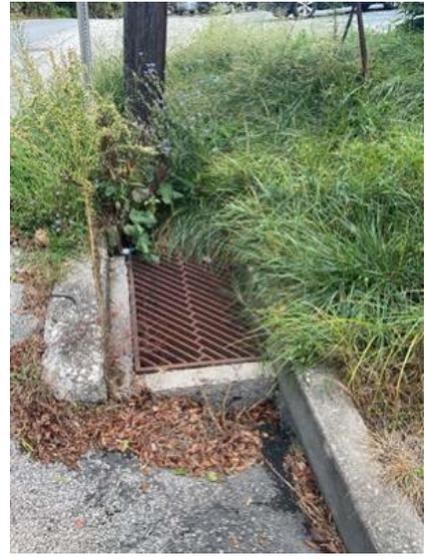
<b>Asset Type</b>	<b>Asset ID</b>	<b>Condition</b>	<b>Notes</b>
Inlet	LVC-IN-0014C	Near Failure	-
Inlet	LVC-IN-0017A	Near Failure	-
Inlet	LVC-IN-0017C	Near Failure	-
Inlet	RC-IN-0004B	Near Failure	-
Inlet	RC-IN-0004C	Near Failure	-
Inlet	RC-IN-0004L	Near Failure	-
Inlet	RC-IN-0041B	Near Failure	-
Inlet	RC-IN-0042A	Near Failure	-
Inlet	RC-IN-0057A	Near Failure	-
Inlet	RC-IN-0137A	Near Failure	-
Stormwater Conveyance	SWC-0288	Needs Repair	-
Stormwater Conveyance	SWC-0576	Needs Repair	Slate landscaping stones
Stormwater Conveyance	SWC-0593	Needs Repair	-
