**STORMWATER MASTER PLAN  
FOR  
WILLISTOWN TOWNSHIP, CHESTER COUNTY,  
PENNSYLVANIA**

Submitted: April 30, 2024

Herbert, Rowland & Grubic, Inc.  
501 Allendale Road, Suite 203  
King of Prussia, PA 19406  
484.460.7050  
[www.hrg-inc.com](http://www.hrg-inc.com)

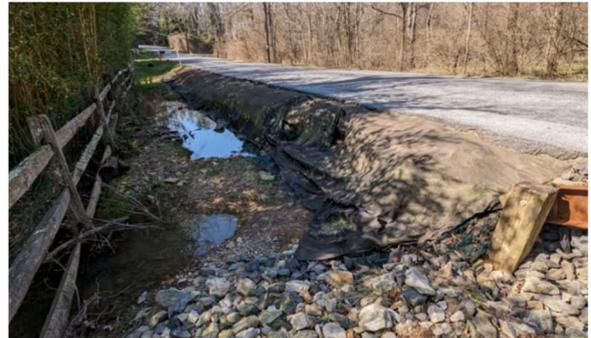
Figure 10: Erosion of roadside swale

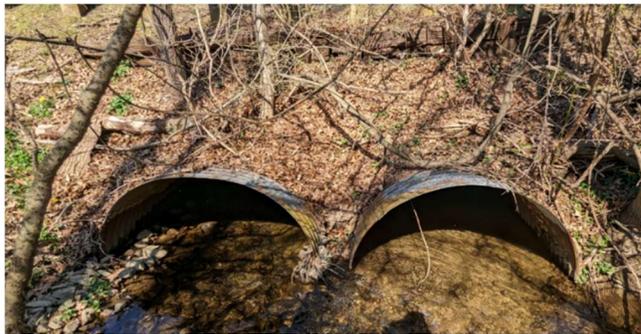
<p><i>Figure 8: Drainage area map of PA-3</i></p>
Primary Flow Paths:	Flow conveyed from upper area of watershed through Crum Creek to the culvert
Drainage Issues:	<ul style="list-style-type: none"> <li>■ Severe flooding at the culvert crossing/roadway overtopping resulting in road closures</li> <li>■ Deteriorating pavement; erosion of road bank</li> <li>■ Debris build-up upstream of culvert</li> <li>■ Failing corrugated metal pipe (field investigation assessment)</li> </ul>
Cause of Problem:	<ul style="list-style-type: none"> <li>■ Failing and undersized culvert pipe; pipe capacity issues</li> <li>■ Debris build-up at culvert; flow-blockage</li> <li>■ Sediment build-up within culvert; flow-blockage</li> <li>■ Lack of upstream stormwater management features; minimal stormwater controls</li> </ul>

Figure 11: Downstream view of culvert

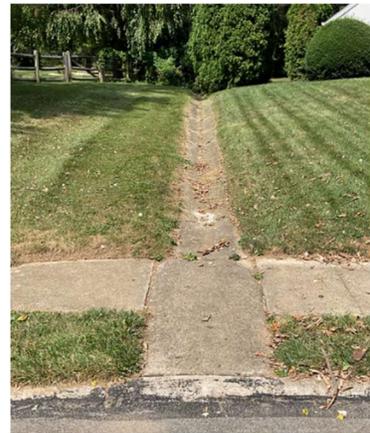
Cause of Problem:	<ul style="list-style-type: none"> <li>■ Lack of adequate inlet collection system</li> <li>■ Pipe capacity issues (i.e. undersized, concrete swales increase flow rates and runoff volume). Note: storm sewer pipe network downstream of Problem Area was not locatable during field data collection due to dense vegetation.</li> <li>■ Lack of upstream and downstream stormwater management features; minimal stormwater controls</li> </ul>

Figure 14: Existing concrete swale draining to cul-de-sac

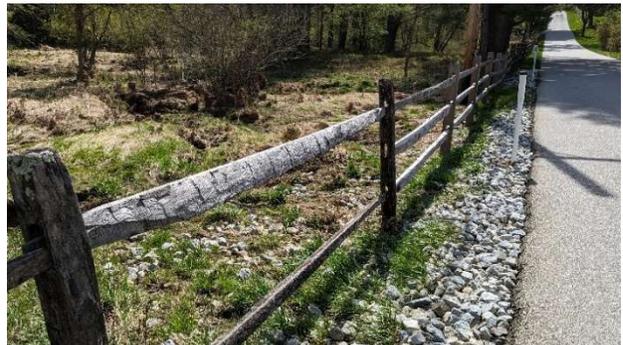
<p>Figure 20: Drainage area map of PA-15</p>
Primary Flow Paths:	Flow conveyed from upper area of watershed through Crum Creek to the culvert
Drainage Issues:	<ul style="list-style-type: none"> <li>■ Flooding at the culvert crossing/roadway overtopping regularly resulting in road closures</li> <li>■ Deteriorating pavement</li> <li>■ Failing corrugated metal pipe (field investigation assessment)</li> </ul>
Cause of Problem:	<ul style="list-style-type: none"> <li>■ Failing and undersized culvert pipes; pipe capacity issues</li> <li>■ Sediment build-up within culvert; flow-blockage</li> <li>■ Lack of upstream stormwater management features; minimal stormwater controls</li> </ul>

Figure 22: View of flattened foliage on downstream side of road indicating recent road flooding

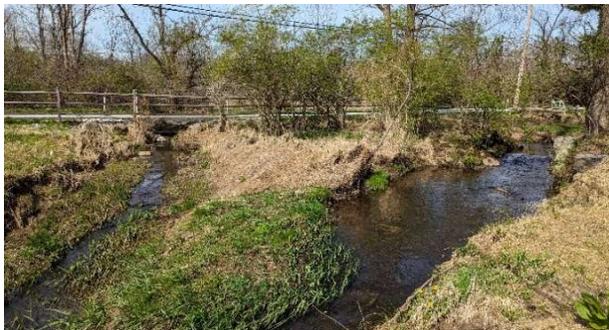
Figure 23: View of road crossings where stream recombines

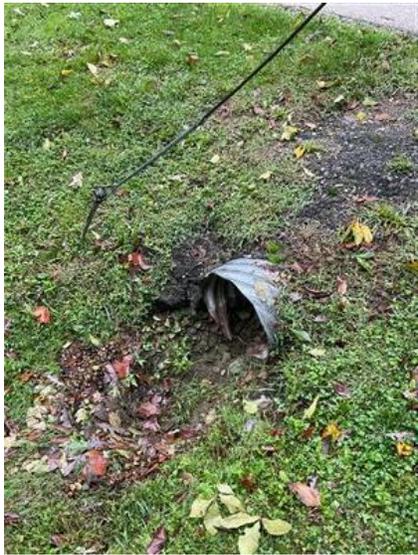
CONDITIONS ASSESSMENT SUMMARY			
Asset Type	Asset ID	Condition	Notes
Outfall	CC-0013	Near Failure	-
Outfall	CC-0019	Near Failure	Dry weather flow origin unknown
Outfall	CC-0024	Near Failure	-
Outfall	CC-0026	Near Failure	-
Outfall	CC-0031	Near Failure	Severe undercutting of foundation
Outfall	CC-0068	Near Failure	20" CMP
Outfall	CC-0105	Near Failure	-
Outfall	CC-0109	Near Failure	-
Outfall	CC-0011	Near Failure	-
Outfall	CC-0120	Near Failure	Pipe size unknown
Outfall	CC-0121	Near Failure	-
Outfall	CC-0123	Near Failure	Pipe partially collapsed endwall beginning to fail. Two pipes in outlet.
Outfall	CC-0124	Near Failure	-
Outfall	CC-0130	Near Failure	-
Outfall	CC-0144	Near Failure	Pipe heavily silted size unknown
Outfall	CC-0159	Near Failure	-
Outfall	CC-0167	Near Failure	10 x 17 elliptical outlet
Outfall	CC-0171	Near Failure	-
Outfall	CC-0172	Near Failure	-
Outfall	CC-0178	Near Failure	HRG created name 3/15/2024, Western Outfall on Creek Road

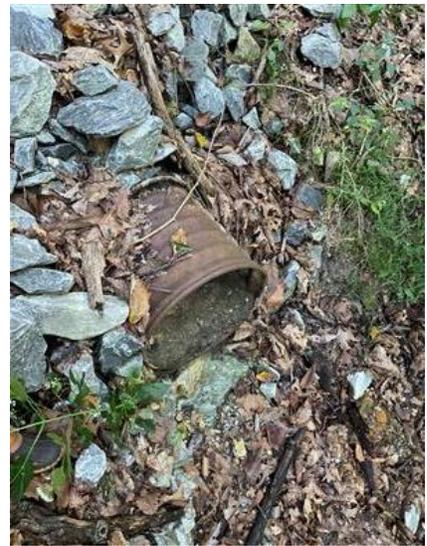
Outfall	LVC-0007	Near Failure	Rusty and heavily silted.
Outfall	LVC-0008	Near Failure	10" PVC
Outfall	LVC-0014	Near Failure	-
Outfall	RC-0006	Near Failure	-
Outfall	RC-0063	Near Failure	-
Outfall	RC-0092	Near Failure	Pipe is exposed, and water is under cutting road

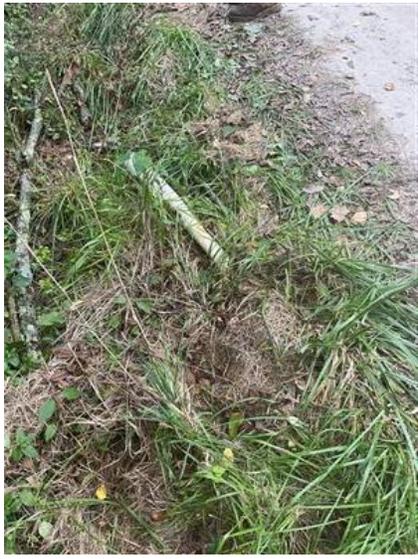
Asset Type	Asset ID	Condition	Notes
Outfall	CC-0001	Failed	15" x 27" CMP outfall
Outfall	CC-0004	Failed	-
Outfall	CC-0025	Failed	Unable to tell if actual outlet. Covered by debris.
Outfall	CC-0028	Failed	Outfall area is sunk below road grade
Outfall	CC-0053	Failed	Pipe buried cannot determine size
Outfall	CC-0058	Failed	-
Outfall	CC-0070	Failed	Endwall is collapsing onto pipe.
Outfall	CC-0077	Failed	-
Outfall	CC-0085	Failed	-
Outfall	CC-0114	Failed	-
Outfall	CC-0117	Failed	Pipe completely silted in
Outfall	CC-0125	Failed	Pipe size and shape unknown
Outfall	CC-0129	Failed	18" x 29" arch
Outfall	CC-0163	Failed	Outlet fully blocked by soil
Outfall	CC-0166	Failed	-
Outfall	CC-0177	Failed	-
Outfall	LVC-0001	Failed	21 inch RCP
Outfall	LVC-0004	Failed	-
Outfall	LVC-0010	Failed	Last pipe section disconnected from rest of pipe. Two pipes at this outfall.
Outfall	RC-0042	Failed	Could not locate assumed to be buried
Outfall	RC-0045	Failed	-

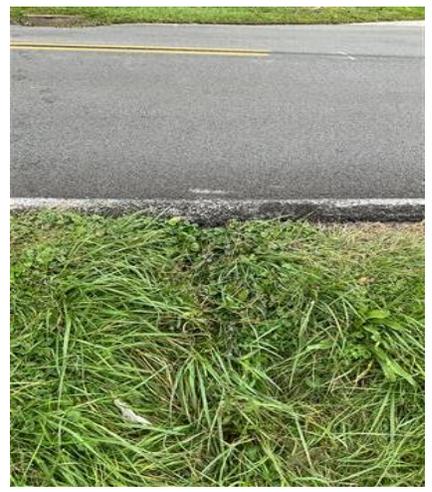
Outfall	RC-0051	Failed	-
Outfall	RC-0056	Failed	Heavy siltation, outfall information unknown
Outfall	RC-0057	Failed	-
Outfall	RC-0060	Failed	-
Outfall	CC-0005	Near Failure	-

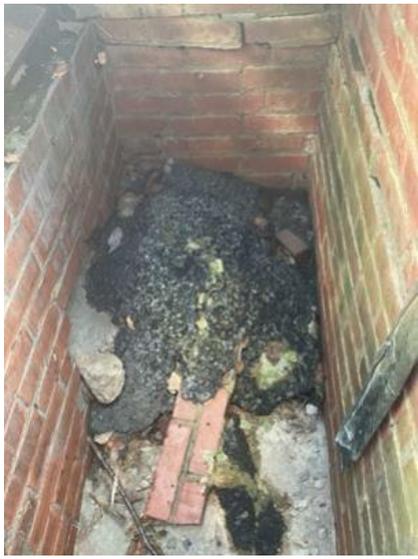
CONDITIONS ASSESSMENT SUMMARY			
Asset Type	Asset ID	Condition	Notes
Inlet	CC-IN-0021C	Failed	-
Inlet	CC-IN-0024B	Failed	Incoming pipe blocked with asphalt and debris
Inlet	CC-IN-0028A	Failed	-
Inlet	CC-IN-0064A	Failed	-
Inlet	CC-IN-0064B	Failed	-
Inlet	CC-IN-0101A	Failed	Curb cut street inlet to swale
Inlet	CC-IN-0159A	Failed	Original invert, has separated from rest of pipe
Inlet	CC-IN-0162A	Failed	Inlet is not draining water. Standing water above the frame. Unable to determine any characteristics.
Inlet	CC-IN-0163A	Failed	Inlet completely full of sediment
Inlet	CC-IN-0166A	Failed	-
Inlet	CC-IN-0174A	Failed	Two 15 x 20 elliptical pipes
Inlet	CC-IN-0175A	Failed	-
Inlet	CC-IN-0177A	Failed	-
Inlet	CC-IN-9999D	Failed	Inlet is also the outlet no bottom (Placeholder name unknown pipe connections Goshen Road)
Inlet	LVC-IN-0010F	Failed	Filled to grate with silt unable to determine pipe info and inlet box information

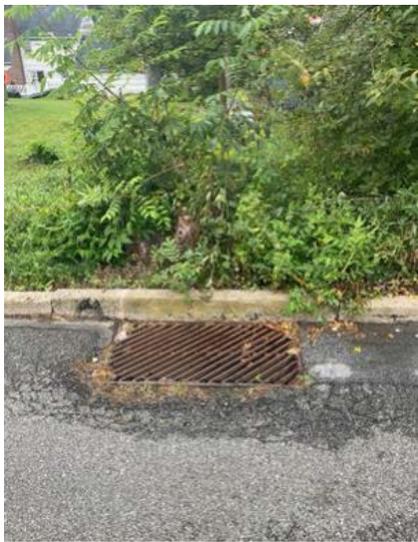
Asset Type	Asset ID	Condition	Notes
Inlet	CC-IN-0028B	Near Failure	-
Inlet	CC-IN-0035B	Near Failure	-
Inlet	CC-IN-0054A	Near Failure	Brick falling off wall
Inlet	CC-IN-0059A	Near Failure	-
Inlet	CC-IN-0059B	Near Failure	-
Inlet	CC-IN-0072A	Near Failure	-
Inlet	CC-IN-0081B	Near Failure	-
Inlet	CC-IN-0125A	Near Failure	-
Inlet	CC-IN-0128G	Near Failure	-
Inlet	CC-IN-0128H	Near Failure	-
Inlet	CC-IN-0152A	Near Failure	-
Inlet	CC-IN-0156D	Near Failure	Brick wall, on verge of collapsing
Inlet	CC-IN-0164A	Near Failure	-
Inlet	CC-IN-0178C	Near Failure	-
Inlet	CC-IN-0179A	Near Failure	Bottom failed in multiple locations
Inlet	CC-IN-0179B	Near Failure	Bottom failed in multiple locations
Inlet	CC-IN-0180A	Near Failure	-
Inlet	CC-IN-0180B	Near Failure	-
Inlet	CC-IN-9999B	Near Failure	Place holder name (Harvey Lane)
Inlet	LVC-IN-0001F	Near Failure	-
Inlet	LVC-IN-0001H	Near Failure	Combination inlet
Inlet	LVC-IN-0003A	Near Failure	-

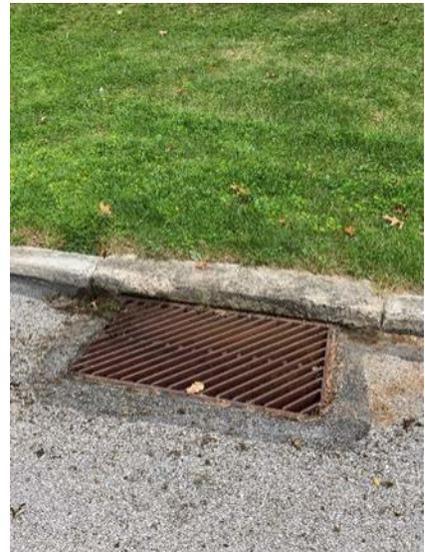
Inlet	LVC-IN-0003D	Near Failure	Part of corner wall missing

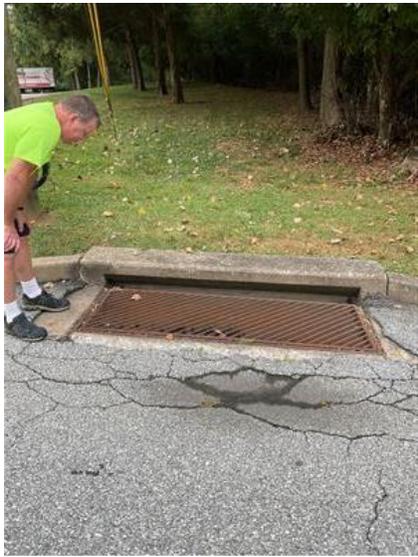
<b>Asset Type</b>	<b>Asset ID</b>	<b>Condition</b>	<b>Notes</b>
Inlet	LVC-IN-0014C	Near Failure	-
Inlet	LVC-IN-0017A	Near Failure	-
Inlet	LVC-IN-0017C	Near Failure	-
Inlet	RC-IN-0004B	Near Failure	-
Inlet	RC-IN-0004C	Near Failure	-
Inlet	RC-IN-0004L	Near Failure	-
Inlet	RC-IN-0041B	Near Failure	-
Inlet	RC-IN-0042A	Near Failure	-
Inlet	RC-IN-0057A	Near Failure	-
Inlet	RC-IN-0137A	Near Failure	-
Stormwater Conveyance	SWC-0288	Needs Repair	-
Stormwater Conveyance	SWC-0576	Needs Repair	Slate landscaping stones
Stormwater Conveyance	SWC-0593	Needs Repair	-

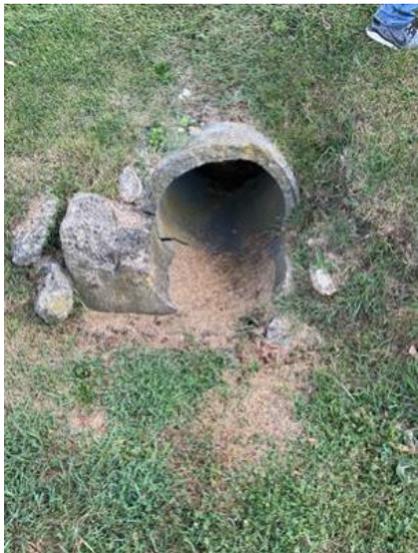
Inlet	RC-IN-0002E	Failed	-
Inlet	RC-IN-0044A	Failed	Headwall has deteriorated blocking entrance to culvert
Inlet	RC-IN-0052A	Failed	-
Inlet	RC-IN-0056A	Failed	Grate size is 3' x 3'
Inlet	RC-IN-0063A	Failed	Bottom of pipe rusted out, Its marked as RC 30?
Inlet	CC-IN-0009A	Near Failure	-
Inlet	CC-IN-0013A	Near Failure	-
Inlet	CC-IN-0023A	Near Failure	-
